ONTARIO HYDRO
RESEARCH DIVISION REPORT

METALLURGICAL ANALYSIS OF FAILED CO/ALR DEVICES

M. Leger

job	file	date	report no.
740623-262-221	823 22	February 2, 1978	78-54-R

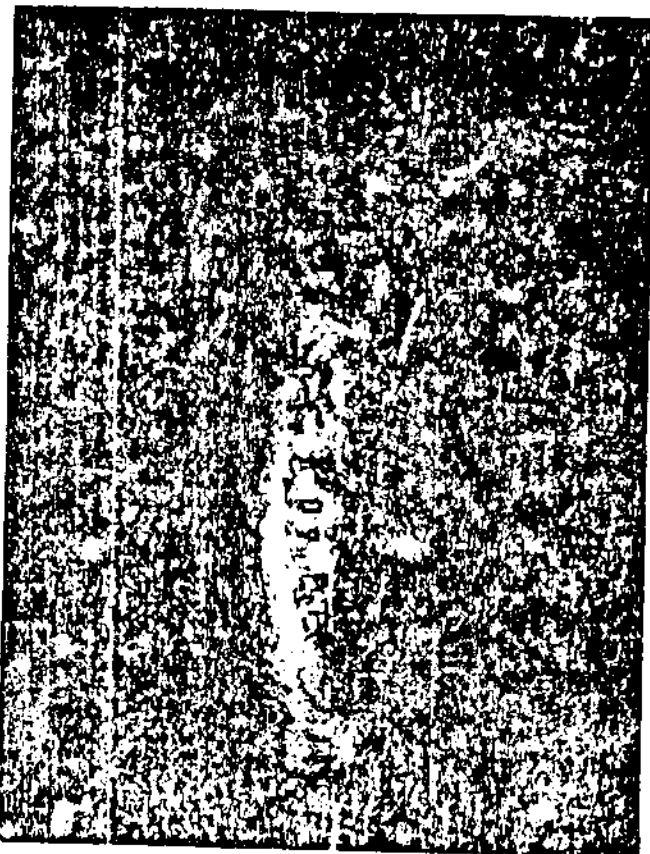
It is apparent that for receptacle B, the first possibility can be ruled out since mechanical marks on the wires indicated that the screws had been tightened. Arcing damage was found adjacent to an impression of the baseplate in the wire.

Figure 1: Impression of baseplate on wire adjacent to arcing damage

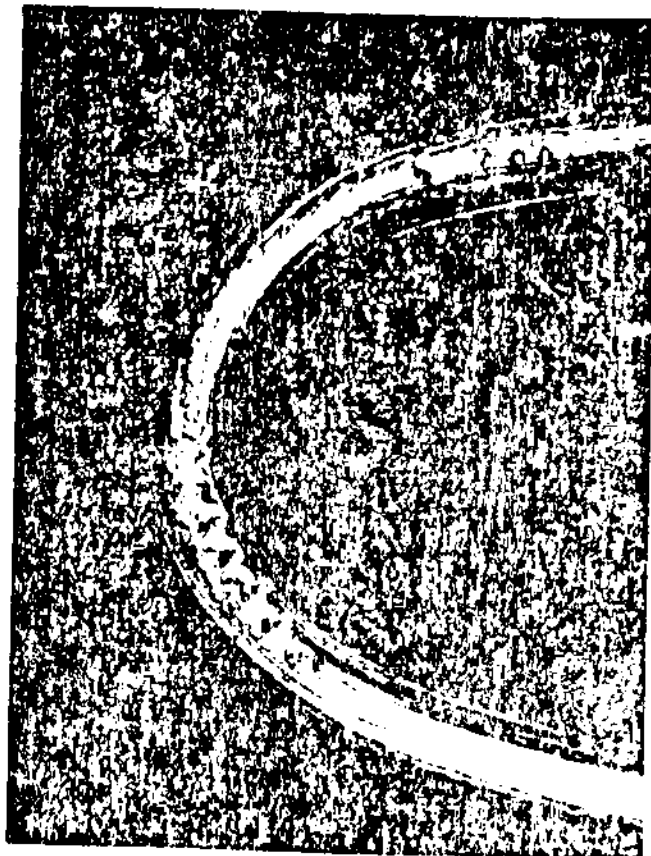
Since the wires for this receptacle were included, an attempt was made to estimate torques used on the wires by comparing mechanical damage observed on the wires with damage created on wires connected to similar receptacles with known torques. A successful comparison was obtained for one wire from the live side and one from the neutral side. The wire from the live side exhibited severe arcing damage but in addition, an impression of the baseplate was clearly visible (Figure 1). This impression corresponded well with the impression created using a 0.56 N.m torque on the screw (Figure 2). The areas where the screw touched the wire were damaged by arcing but showed that the screw was touching in two places. The wire from the neutral side exhibited mechanical damage on the screw side which corresponded to a 0.33 N.m torque.

Figure 2: Impression of baseplate at 0.56 n.m. torque

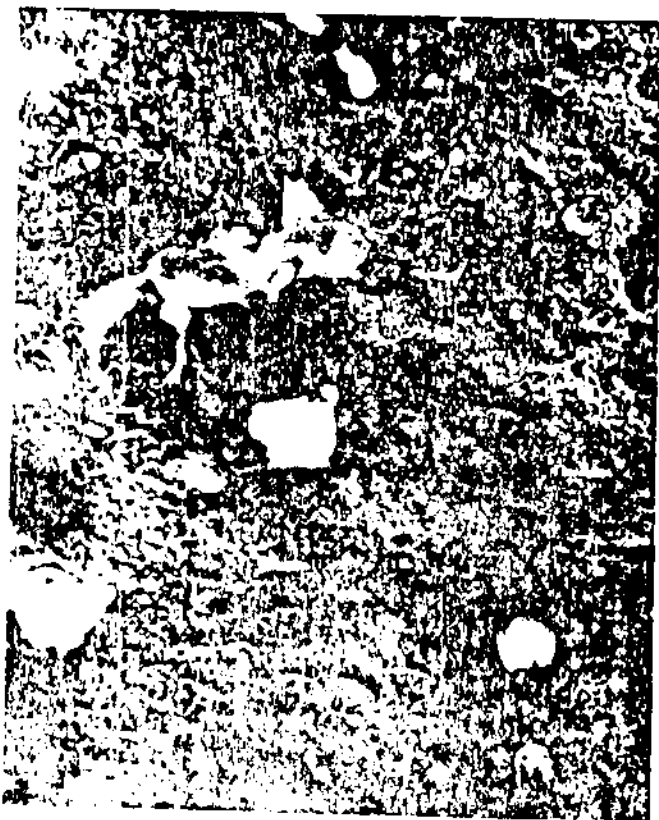
Two areas of the baseplate were photographed and analysed, these are shown as Figures 3 and 4. Particles on the surfaces were also analysed. Most contained aluminum, some had copper, zinc, silicon and calcium. Analysis of general surface areas revealed that there were often zinc concentrations on the surface which were significantly higher than would be expected for the normal brass composition. In the area shown in Figure 4, the surface appears cracked. High concentrations of indium, chlorine and zinc were found in this area.

Figure 3: Slightly damaged area of baseplate - Receptacle A
x 140 mag

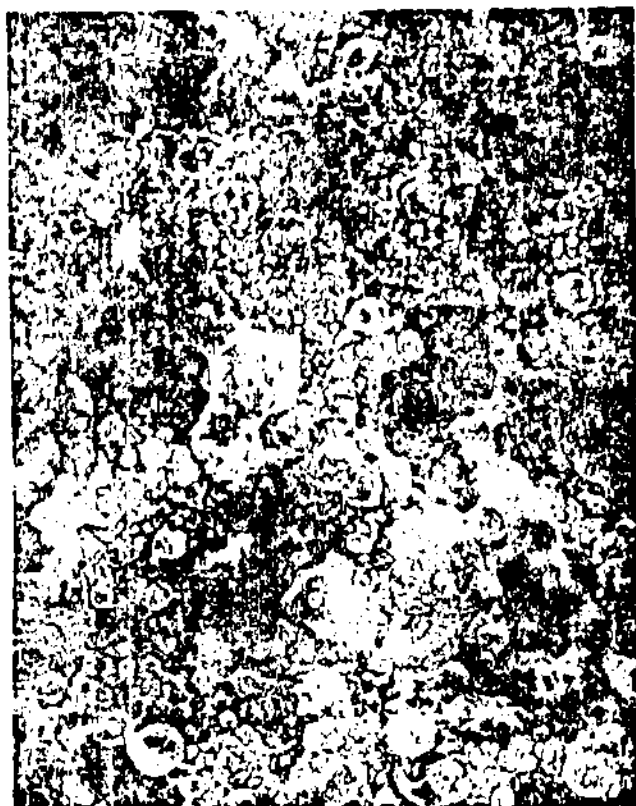
The underside of the screw of terminal 1 of the receptacle was also examined. A typical area where arcing was observed is shown in Figure 5. X-ray analysis showed high concentrations of aluminum, zinc and copper. No other elements were detected. Again, the zinc level was significantly higher than the copper in the overall surface analysis.

Figure 5: Arcing damage under screw head x 120 mag

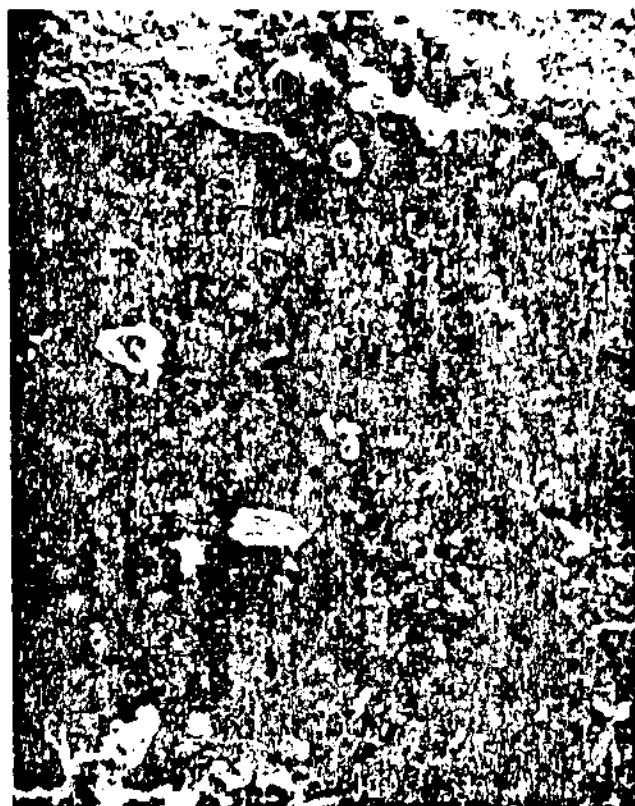
Two different areas under terminal 3 were examined. An area where the indium-tin plating (found by optical spectroscopy) was deformed can be seen in Figure 6. X-ray analysis of the overall surface in this area showed that the plating was indium or tin but also that zinc, copper, sulphur, chlorine and aluminum were also present in significant quantities. Analysis of particles on the surface indicated very high concentrations of aluminum and chlorine. A similar analysis of the surface of one of the pyramidal depressions in the surface showed an increased ratio of zinc to copper. Other particles found on the surface where the wire had been showed little aluminum but large amounts of chlorine and zinc.

Figure 6: Deformation and particles on plating x 600 mag

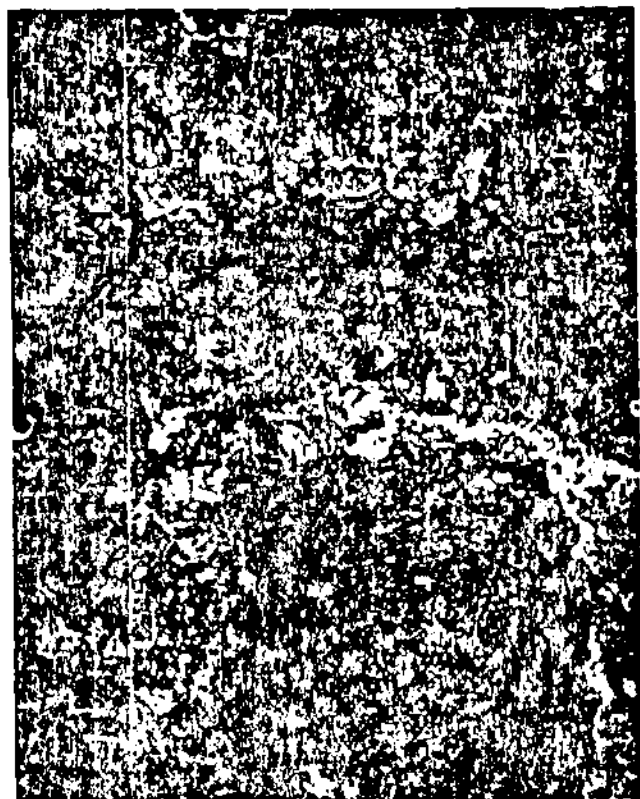
Areas removed from the points of contact of the aluminum wire also showed large quantities of particles (Figure 7).

Figure 7: Surface appearance removed from contact area x 300 mag
