HAZARD ANALYSIS

U.S. CONSUMER PRODUCT SAFETY COMMISSION
Bureau of Epidemiology
Washington, D.C. 20207

HAZARD ANALYSIS
OF
ALUMINUM WIRING

April 1975

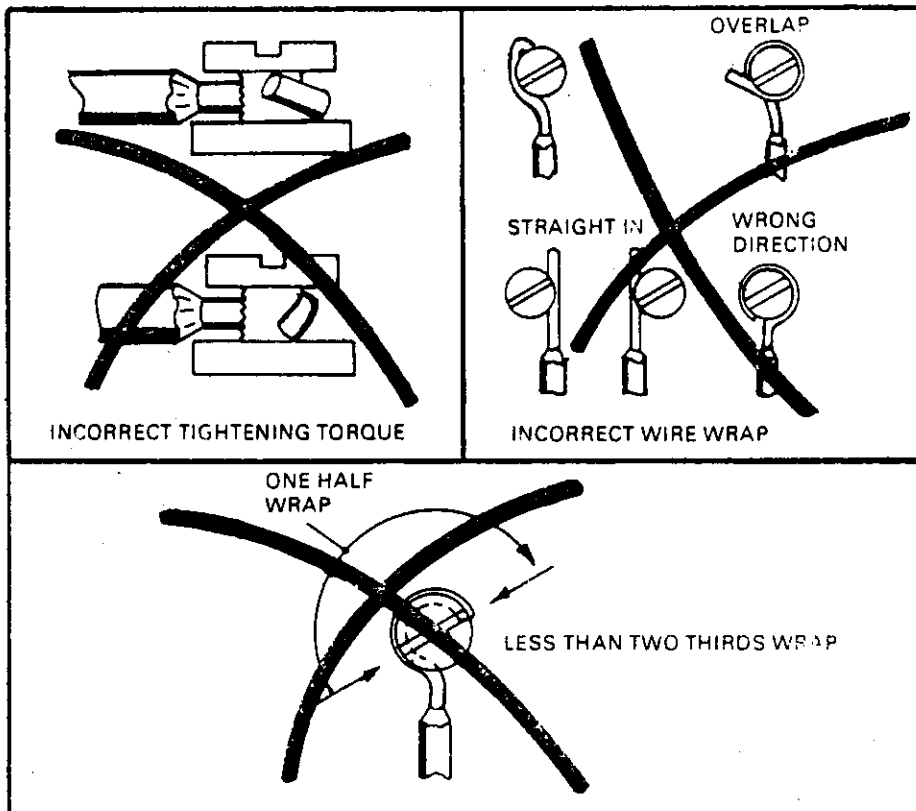
FIGURE 3

Figure 3 illustrates incorrect methods for connection and should not be used.

INCORRECT METHODS OF TERMINATING ALUMINUM WIRE AT WIRE-BINDING SCREW TERMINALS OF RECEPTACLES AND SNAP SWITCHES
