ANALYSIS OF FIELD FAILURES OF ALUMINUM-COPPER PIGTAIL SPLICES MADE WITH TWIST-ON CONNECTORS

Jesse Aronstein
Consulting Engineer
Poughkeepsie, New York

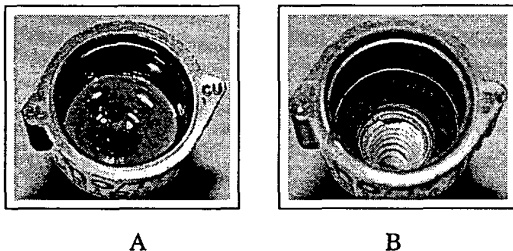
The connector's insulating shell is a thermoplastic. In the open end of the connector shell is an insert that helps prevent escape of the corrosion inhibitor compound from inside the connector. Removing the plastic insert reveals the inhibitor filling, as seen in Figure 3A. With the inhibitor removed, the zinc-plated steel connector spring can be seen, as shown in Figure 3B.

A B
**FIGURE 3 - INSERT REMOVED, SHOWING
INHIBITOR (A) AND SPRING (B)**

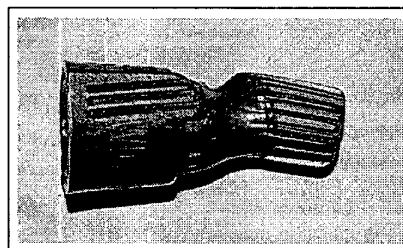
FIGURE 4 - EARLY STAGE OF OVERHEATING

The failures shown in Figures 4 and 5 show heat damage around the plastic shell corresponding to the portion of the connector spring that is in contact with the spliced wires. This heating pattern is characteristic of failing twist-on connector splices made with aluminum and aluminum-copper wire combinations. As the failure progresses with time, higher temperatures are developed at the splice and at the connector shell, leading to melting and charring of the plastic.

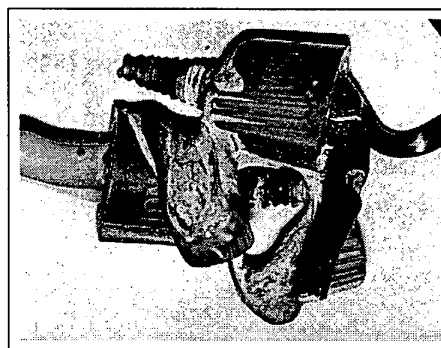
FIGURE 5 - TWO FAILED SPLICES ADHERED TOGETHER BY MELTED PLASTIC SHELLS

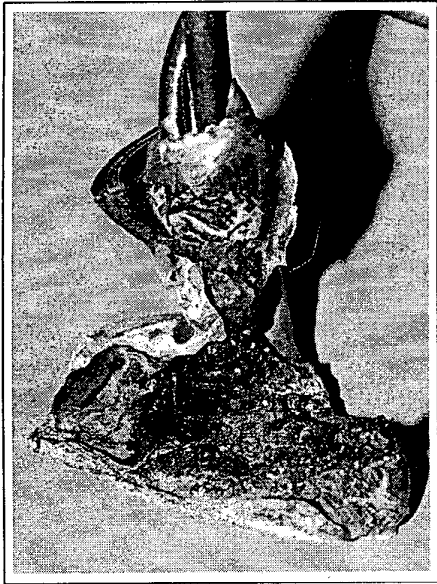
FIGURE 6 - SEVERE FAILURE, PLASTIC SHELL MELTED AND CHARRED

The hot plastic flows downward due to gravity, and the final appearance of the failing connectors therefore varies according to the physical orientation in addition to the level of heat generation. The connector shown in Figure 6 shows the downward flow of the plastic. The severe charring of the plastic from this connector indicates that the plastic shell may have actually ignited. Both the insulating plastic shell of these connectors and the inhibitor compound inside are easily ignited and burn readily.

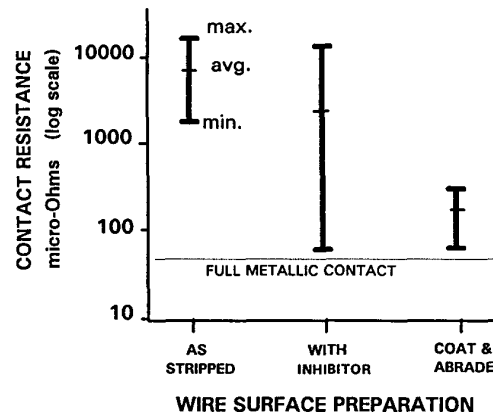
FIGURE 7 - CROSSED-ROD CONTACT RESISTANCE AT 3 kg AS A FUNCTION OF SURFACE PREPARATION (Composite including all three wire types)

Without surface preparation, just as the aluminum wire surface exists after the electrical insulation is stripped off, all three aluminum conductor samples demonstrate high resistance in the 3 kg crossed wire contact tests. The apparent area of contact is a circle measured to be about 0.6 mm diameter. The contact resistance of a fully-metallic circular aluminum contact of that diameter is approximately 50 $\mu\Omega$, calculated as per Holm.[15] Without any surface preparation, contacts with these aluminum conductors average more than two orders of magnitude higher resistance than a fully-metallic contact under the same conditions. In the as-stripped condition, the results are essentially the same for the three types of aluminum conductor.

Application of inhibitor compound (taken from inside one of the new twist-on connectors) to the wire surface prior to contact engagement results in some reduction of contact resistance, on average. There is a significant difference in the effectiveness of the inhibitor from one conductor sample to another. The overall average contact resistance for samples treated with the inhibitor is almost two orders of magnitude greater than for a fully-metallic contact.

Average contact resistance was minimized when the aluminum wire was coated with petrolatum and then abraded using a #400 grit abrasive paper. With this surface, average contact resistance is about an order of magnitude lower than with the inhibitor treatment, and only three times that of a fully-metallic contact. The effect was consistent for all of the wire types.
