SUMMARY REPORT

STUDY OF OVERHEATING OF ALUMINUM-WIRED
ELECTRICAL RECEPTACLES IN SCARBOROUGH,
TORONTO, HOMES.

Issued: January 11, 1982

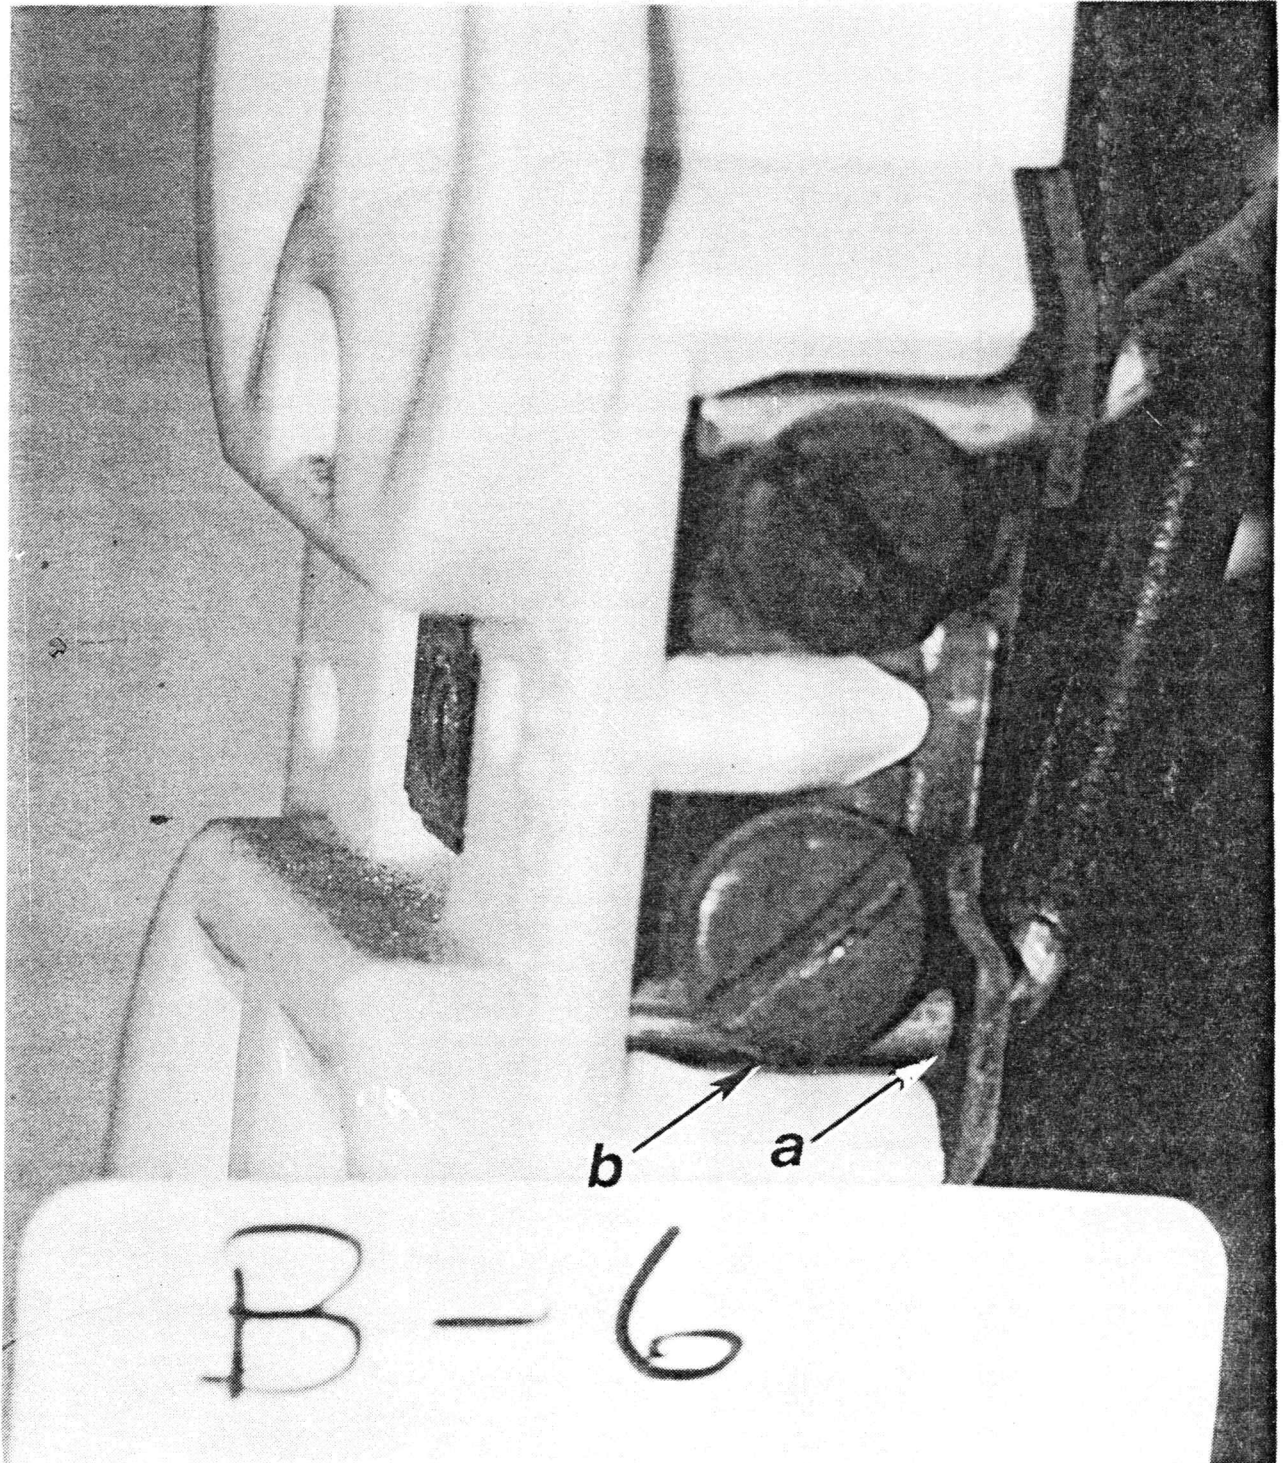
1. Number of Homes Studied: Three
2. Age of Homes: 13 years (approximate)
3. Builder (Developer): Alcan
4. Electrical Contractor: Ainsworth Electric
5. Type of Receptacles: Leviton, Canada, Catalog 1297-I.
The receptacles are connected to the aluminum wire as shown in Figure 1. This type of receptacle, and the method of connection, were approved for use with aluminum wire at the time of installation. The type of contact established between the terminal screw and the aluminum wire is a "straight-in, sidewired" connection in which the wire is tightened under one side of the binding head screw. (The manufacturer considers this a "back-wiring" method, because of the guide through which the wire is inserted, but this has no relevance to the type of termination.)

FIGURE 1 - Receptacle With Straight-in Sidewiring.
Conductor is inserted through wire guide, "a",
and tightened under screw, "b".
