# **REDUCING THE FIRE HAZARD**

# **IN ALUMINUM-WIRED HOMES**

**Jesse Aronstein, PH.D., P.E.**  
Vice President, Special Engineering Projects,  
Wright-Malta Corp., Ballston Spa, NY  
*(When this report was originally written)*

**Latest update: November 25, 2011 \***

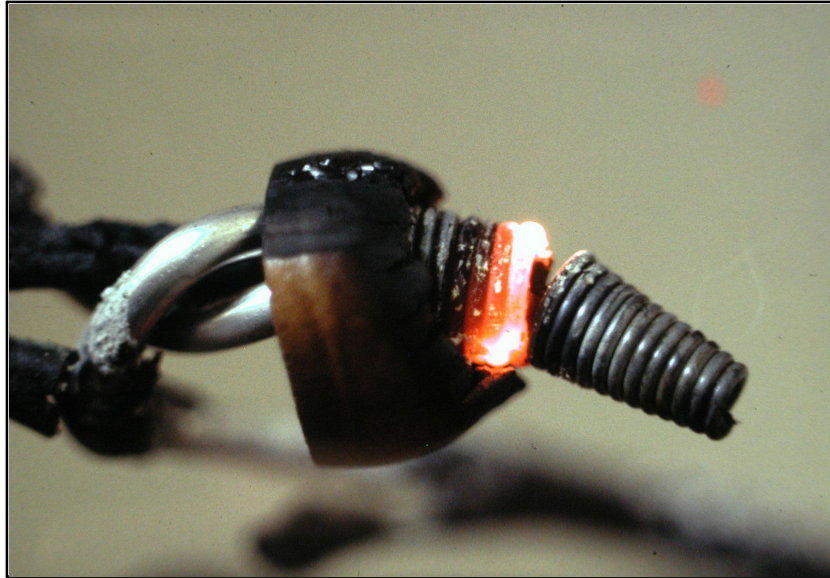
**FIGURE 1 - ALUMINUM WIRE SPLICES MADE WITH TWIST-ON CONNECTORS CAN BE DANGEROUS.** The use of most types of twist-on connectors with aluminum wire can lead to hazardous results. This twist-on pigtail connection (two #10 aluminum wires with one #12 copper wire, in a 20-amp circuit), made with a twist-on connector that was UL listed for use with aluminum wire at the time, remains electrically functional in the circuit, but it becomes extremely hot whenever a significant amount of current flows. The heat has deteriorated the insulation on both the connector and the wires. In this photo, a portion of the connector's spring is red hot, at current well below the circuit rating.

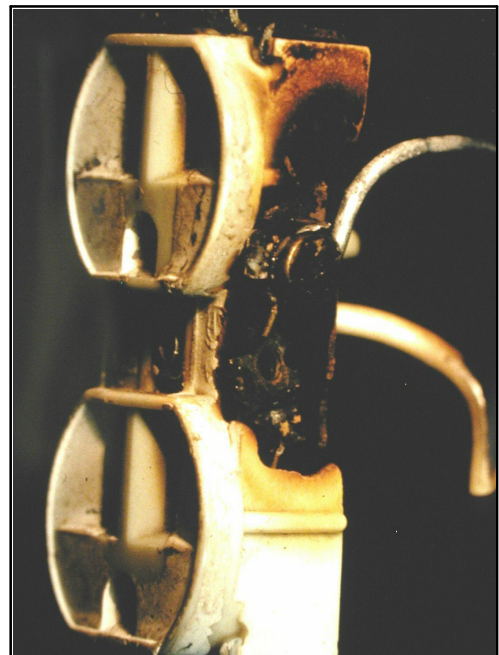
**FIGURE 2 - EXAMPLE: OVERHEATING OF ALUMINUM-WIRED TERMINALS ON A RECEPTACLE.** Enough heat was generated by current flowing through the aluminum wire connections to cause charring of the receptacle body and disintegration of the insulation that was on the wire. Note that the face of the receptacle, as the homeowner or an inspector would have seen it, with the cover plate on, would look normal.

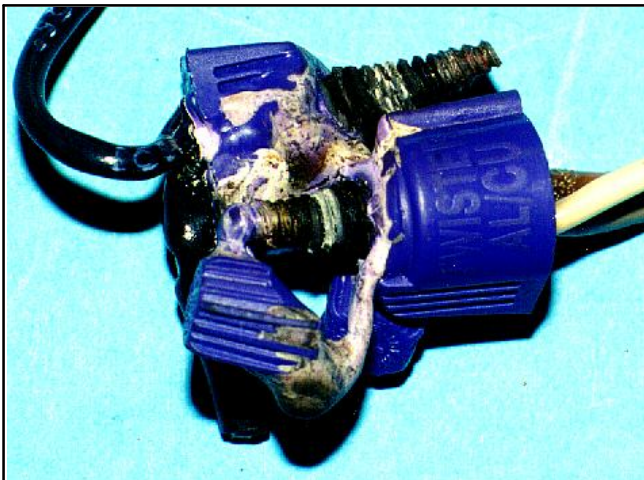
A. These two failed splices are adhered together by the melted plastic insulating shells.

**FIGURE 5 - FIELD FAILURES OF ALUMINUM TO COPPER SPLICES MADE WITH IDEAL #65 CONNECTORS [12]**

3. IDEAL #65: came on the market in the mid 1990's. Within three years of its introduction, the first report of field failure surfaced. [12] There have been additional failures reported since then.

Additionally, field burnouts have now been reported with the Ideal #65 connectors in their rated applications. With CPSC skeptical (and requesting that UL withdraw its listing), the manufacturer initially agreeing that the connector is not for the pigtail retrofit application, independent tests clearly demonstrating poor performance, and field failures reported, the use of the Ideal #65 "Twister" connector for the pigtail application is definitely not recommended. If the COPALUM repair is not available, use the AlumiConn connector (See Section 1C).

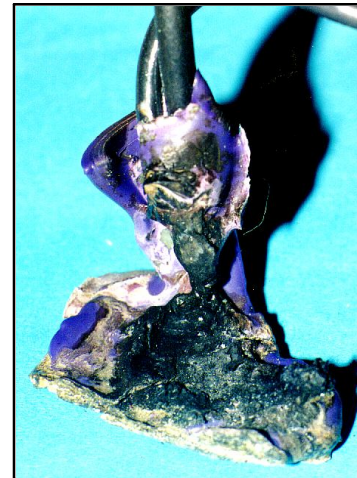
B. Severe failure, plastic shell melted and charred. The charring indicates that it had probably ignited.
