FAILURE OF ALUMINUM CONNECTIONS IN RESIDENTIAL APPLICATIONS

J. Aronstein
Consulting Engineer
Poughkeepsie, NY

Failures of aluminum connections in various residential electrical applications are examined. Specific examples are provided, including aluminum bus bar contacts, aluminum-bodied connectors, and aluminum-shell lamp sockets. Design factors of the failed connections are discussed in terms of criteria for successful long-lived contact to aluminum. Deficiencies of the designs and the applicable qualification standards are discussed. Key words: Aluminum Contacts, Aluminum Connections, Aluminum Busbar, Connection Failure, Qualification Standards.

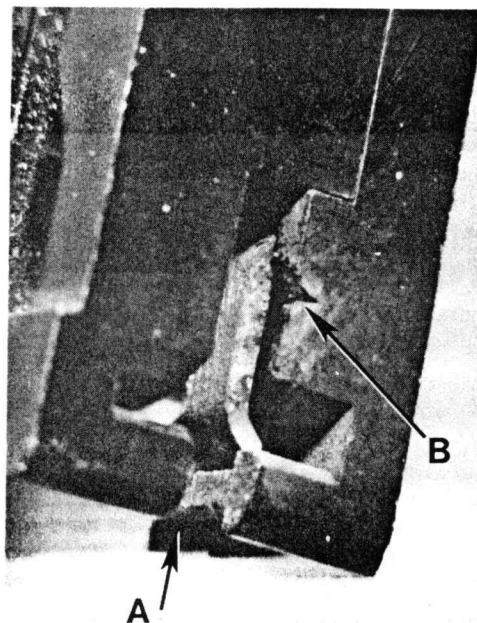
FIGURE 1 - CIRCUIT BREAKER SPRING CLIP CONTACT

(Arrow "A" shows direction of insertion of aluminum busbar finger. Arrow "B" shows case material charred from heat generation at the spring clip contact to aluminum busbar.)

Failures of circuit breaker spring contacts to aluminum busbar (or busbar extensions) are common. The failures involve increasing contact resistance and consequential abnormal heat generation. The spring contact of the breaker shown in Figure 1 is failing, and has overheated in service to the extent that the plastic case material has started to char in the area labelled "B".

Inserting the breaker into the panel, the spring clip engages a mating finger on the bus bar, engaging it in the direction shown by the arrow "A". Contact is established on both sides of the busbar extension, with normal force generated by the spreading apart of the spring clip. Note in Figure 2 that the breaker's stationary make-break contact is constructed as an integral part of the clip (Fig. 2, "B"). This design is cost-effective in manufacturing but has serious deficiencies in terms of contact performance when used in combination with aluminum mating contact members.

The circuit breaker spring clip connections to aluminum busbar have sufficient force and wiping action to establish low resistance contact when first engaged. The spring clip design permits relative motion of the contacting members at the interface, exposing the contact to deterioration due to fretting.[7][8] Microscopic interfacial motion in the circuit breaker spring clip contact results from mechanical disturbance and from differential thermal expansion and contraction effects.

Mechanical disturbance of the circuit breaker spring clip contact interface can occur from such action as removal or installation of other breakers on the same busbar, opening or closing the cover door on the panel, and operation of the breaker's make-break contacts. Closing of the breaker's contacts involves a snap action mechanism that causes the moving contact to impact the contact on the spring clip.

Thermal expansion and contraction also contribute to the interfacial motion between the spring clip and the aluminum busbar. The thermal expansion mismatch between the aluminum and the copper-based mating component causes differential motion in the plane of the contact interface. The relatively large dimensions of the contact area of these connections (Fig. 4 and 5) results in differential interface motion of the same order as the size of the contacting asperities under the normal range of temperature fluctuations. Additional contact interface motion can result from thermal expansion and contraction of the breaker itself and the structure on which it is mounted.

Considering the lack of resistance to contact interface motion, deterioration by fretting is believed to be the most likely initiating factor in the failure process of the circuit breaker spring clip contacts to aluminum busbar. Contacts involving aluminum, plated or unplated, are not resistant to deterioration by fretting.[8]

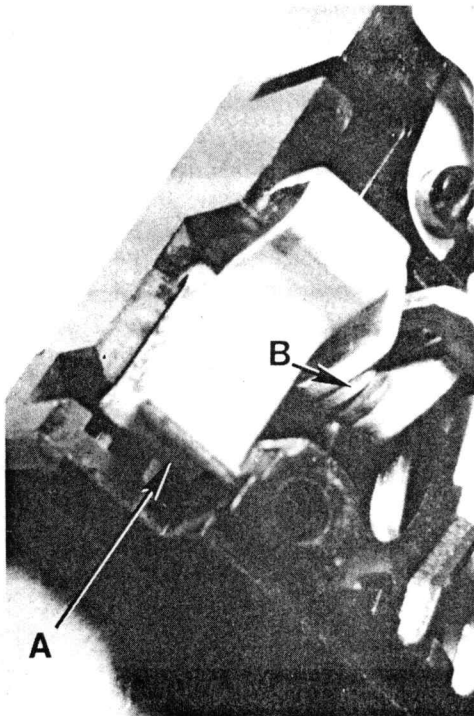
FIGURE 2 - CIRCUIT BREAKER SPRING CLIP CONTACT
Case opened to show construction.

(Arrow "A" shows direction of insertion of aluminum busbar finger. Arrow "B" shows make-break contacts.)

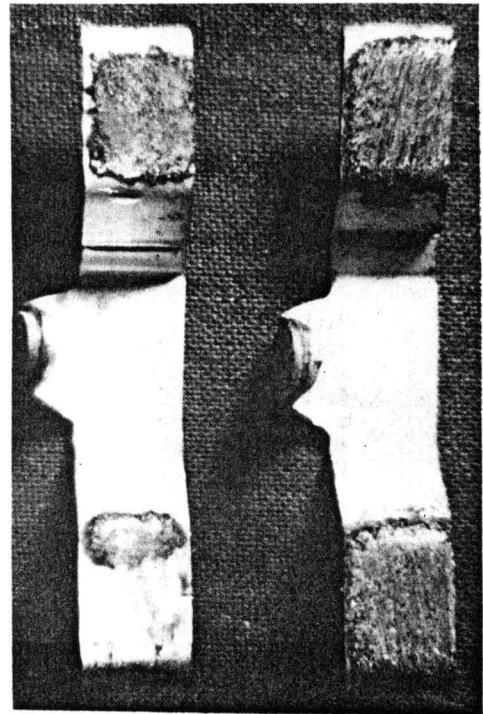
FIGURE 3 - CIRCUIT BREAKER SPRING CLIP CONTACTS
(Bent open to show areas of contact to the aluminum busbar.)

Figure 3 shows two representative failing spring clip (to aluminum) contacts from relatively small (15 and 20 A) circuit breakers of the same type previously shown. The spring clips have been bent open so that the contact areas can be seen. These circuit breaker contact clips are from a residential installation in service for 20 years. Figure 4 is a closeup view of one of these contact areas. Note that the apparent area of contact is relatively large and it has been seriously eroded.

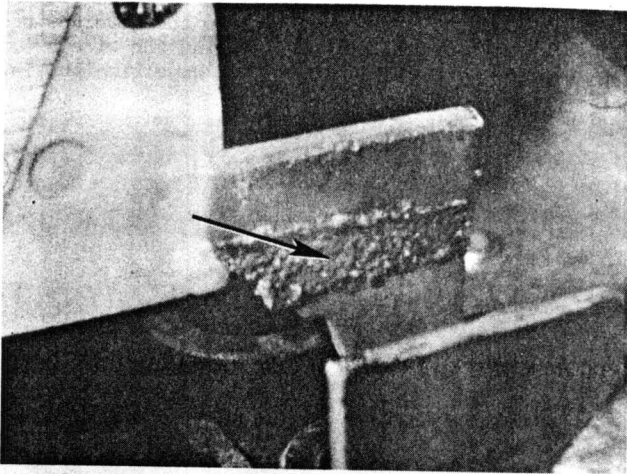
FIGURE 5 - ALUMINUM BUSBAR CONTACT TO 200 AMP MAIN BREAKER.

Figure 5 shows the contact area to an aluminum busbar from a failing spring contact of a 200 A main circuit breaker. In this instance, the contact is single-sided. Severe erosion of the contact surface is again apparent.

(Arrow indicates area of contact.)

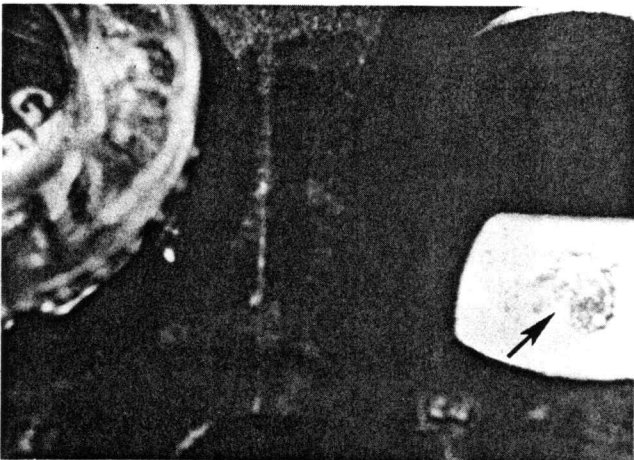
FIGURE 6 - FUSE SOCKETS IN SERVICE PANEL

Some residential service panels utilizing fuses also have pressure contacts to aluminum busbar. One type of design uses cartridge fuses clipped into holders that in turn clip onto the busbar. Another design uses Edison base fuses which screw into a socket in the same manner as a lamp, but with the center contact bearing directly against the aluminum busbar. Figure 6 shows a representative configuration, with a failing contact at the fuse position on the right. An enlarged view of the eroded area of contact on the aluminum bus bar is shown in Figure 7.

(Edison-base fuse makes direct contact to aluminum busbar visible at right with fuse removed. Canadian.)

Fretting is considered to be a major factor in the failure of the fuse contact to the aluminum busbar. Thermal expansion and contraction of the mounting structure is a principal contributor to interfacial motion in this instance. Because of the relatively small dimension across the contact area, differential thermal expansion of the mating contact materials is considered to be less important.

The design is unable to assure that normal force initially established is maintained. The busbar is essentially a flat beam supported between every second fuse. A fuse screwed into place deflects the busbar. When the adjacent fuse, in the same span of the busbar, is screwed into place, the contact force on the first fuse is decreased, increasing the probability of failure.

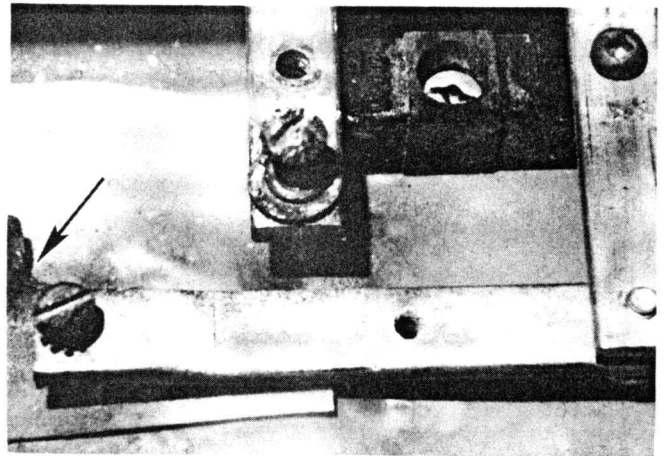
FIGURE 8 - SCREW CONNECTIONS OF ALUMINUM BUSBAR

Busbars in residential panels often consist of several parts, typically secured by steel screw fasteners with lockwashers. Similar connections are used to fasten terminal lugs to the busbar, the tang on the terminal lug serving as an extension of the busbar. Figure 8 shows one such design, in which a failing aluminum busbar interconnection has overheated in service to the extent of burning the insulating separator between the busbar and the back of the panel enclosure.

(Arrow points to burned portion of plastic insulating barrier. Canadian.)

The aluminum busbar interconnection failures are attributed to failure to maintain normal contact force. The use of steel screws to fasten aluminum parts together leads to substantial normal force fluctuations as a result of differential thermal expansion and contraction between the aluminum and the steel. In the limit, yield strength can be exceeded during high temperature operation, resulting in a loose connection on return to low temperature. For the busbar interconnection shown in Fig. 9, for instance, calculations indicate that a temperature rise of 117°C results in complete loosening of the connection upon cooling to normal ambient temperature.[10]

Some designs have the steel screws threaded directly into the aluminum, as in the bus bars shown in Fig. 8. This compounds the problem, since the high stresses present in the threads in the aluminum lead to reduction of the contact normal force due to yielding and/or relaxation effects. Most aluminum busbar materials will yield and/or creep at substantially lower stress than the steel bolt at normal operating temperature.[10]

As a general practice, cupped spring ("belville") washers are recommended for bolted connections with aluminum busbar when steel fasteners are used.[10] The spring washer maintains essentially constant contact interface normal force in spite of the difference in coefficient of thermal expansion between the aluminum and the steel. The busbar and busbar link assemblies that are failing do not have spring washers, but do employ a lockwasher to keep the screw from backing out by thermal ratcheting. The lock washer is not an effective substitute for a cupped spring washer in terms of maintaining contact interface normal force, however.

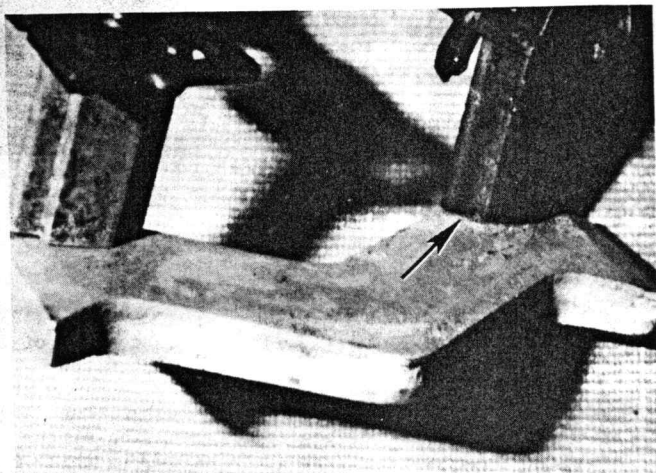
FIGURE 9 - ALUMINUM BUSBAR LINK ASSEMBLY

Figure 9 shows a different type of busbar interconnection. In this instance the bus link assembly consists of two posts and a short link, all of which are made of aluminum. Each post subassembly is held together by an 8-32 steel screw. The bus link assembly is used in a residential panel to carry current across from one breaker insertion position

to another. (Current is fed from a cable welded to the left-hand breaker insertion plate.) In the actual panel installation, most of the bus link assembly visible in Figure 9 is within and behind a plastic insulating block. The backside of the insulating block, corresponding to point on the bus link indicated by the arrow in Figure 9, is shown in Figure 10. The plastic had ignited due to heat generated at the contact between the aluminum post and the flat aluminum link. Smoldering combustion of the plastic insulator is indicated by the white ash residue.

(Arrow shows contact between busbar and post that was originally mounted in the portion of the insulating block shown in Fig. 10.)

The size of the screws is also important, and in some instances they are too small for the application. An example is shown in Fig. 9, in which an 8-32 screw holds the post to the bus bar link. This is inadequate for this interconnection, which in normal service may carry current in excess of 100 A. In terms of current per unit stressed area of the clamping bolt or screw, this connection exceeds recommended values.[10] Additionally, the contact area between the post and the busbar link is small, having a current density of about 700 amps per square inch, far above the recommended design guideline of less than 200 amps per square inch of contact area.[10]

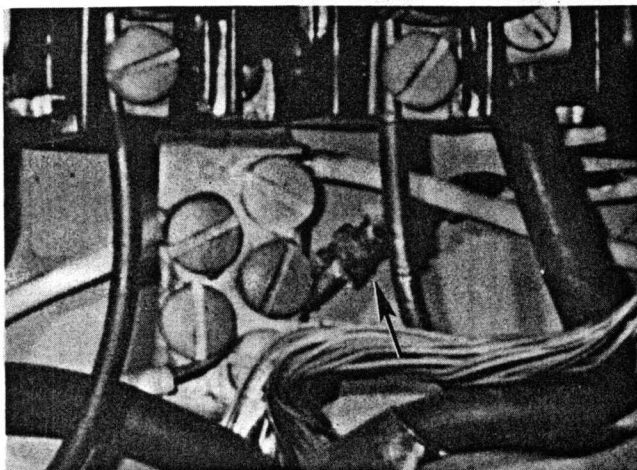
FIGURE 11 - WIRE TERMINALS ON ALUMINUM BUSBAR

The neutral side of the branch circuit wiring in a residential service panel is generally connected to screw terminals incorporated in a busbar, made of aluminum in most residential service panels today. Figure 11 shows the aluminum neutral bus of a residential service panel, with wires connected to it with steel binding head screws. One of the terminations of the copper wire to the aluminum busbar has failed to the extent of damaging the wire's insulation (arrow) as a result of excessive heating at the connection.

(Arrow indicates insulation damage due to overheating termination, copper wire to aluminum busbar, steel screw.

Field failures of copper wire and cable connected to aluminum busbar and aluminum-bodied connectors (Figures 11 and 12) demonstrate weakness in the connection design, in which aluminum and copper are connected together with contact force applied by means of steel screws.

When aluminum is utilized as wire and cable, it is generally recognized that the use of steel screws and copper-based connectors leads to poor performance.[11] Aluminum-bodied connectors were developed to provide compatibility with aluminum wire and cable, but connection performance with copper wire and cable may then be compromised. Additionally, because of the mismatch of both thermal expansion coefficient and electrochemical corrosion potential, the use of steel screws in connections of these types is considered to contribute to the probability of failure.

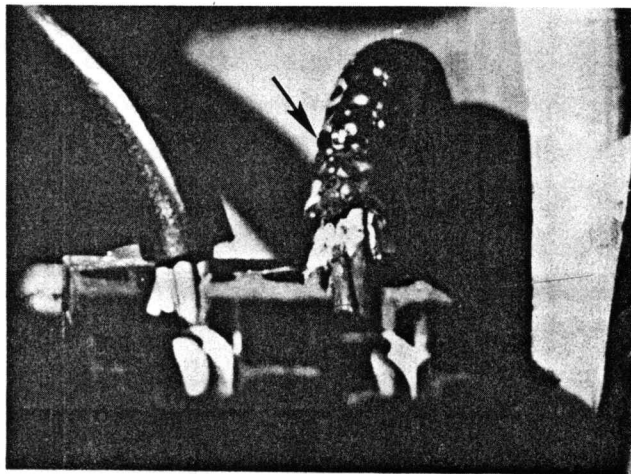
FIGURE 12 - INSULATION DAMAGE DUE TO OVERHEATING OF COPPER CABLE IN ALUMINUM-BODIED CONNECTOR.

Aluminum bodied connectors are widely used in residential electrical systems, for both copper and aluminum conductors. Failures of copper cable terminations at aluminum-bodied connectors occur, as for example that illustrated in Figure 12. Overheating at the connection has resulted in insulation damage on the cable.

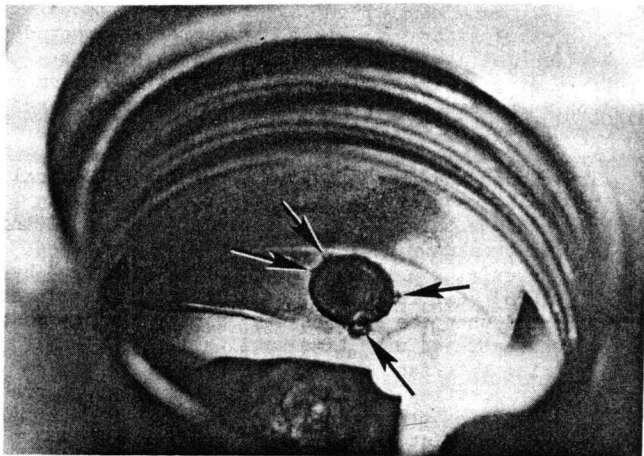
FIGURE 13 - ALUMINUM LAMP SHELL CONTACT

Aluminum is commonly utilized for lamp socket components. An example is the aluminum shell of the socket shown in Figure 13. Failure occurred at the contact between the aluminum screw shell and a brass eyelet (or tube) which is headed over to provide the current path to the wire terminal inside the socket assembly. Sufficient excess heat was generated at this failing connection to destroy the insulation on the wire at the screw termination on the other end of the eyelet.

(Arrows indicate pitting of failing contact between aluminum shell and brass eyelet.)

While the current may be low relative to the other aluminum connection applications, the lamp socket is subjected to relatively high temperature excursions due to heating from the lamp itself. Heating of the eyelet results in an indeterminate initial normal force in the contact with the aluminum lamp shell.

The structure through which the eyelet passes to contact the wire terminal on the backside may be plastic or ceramic, relatively massive and with a different thermal expansion coefficient than the brass eyelet. The failed lamp socket shown in Fig. 13 has a ceramic body. The coefficient of thermal expansion of a ceramic body is approximately 40% that of the brass eyelet, and so the connection tends to loosen as it heats up. While the loosening occurs whether the lamp socket shell is made of brass or aluminum, aluminum is failure prone under such conditions due to the effect called "contact breathing" by Holm.[12]
