# **REDUCING THE FIRE HAZARD**

# **IN ALUMINUM-WIRED HOMES**

**Jesse Aronstein, PH.D., P.E.**  
Vice President, Special Engineering Projects,  
Wright-Malta Corp., Ballston Spa, NY  
*(When this report was originally written)*

**Latest update: November 25, 2011 \***

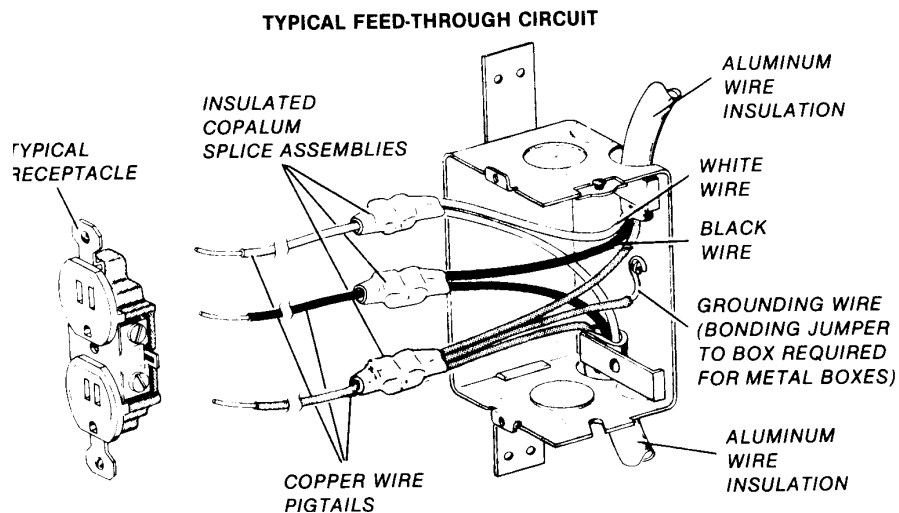
**FIGURE 3 - Illustration of copper wire pigtails spliced to aluminum circuit wires using COPALUM connectors (Source: CPSC)**

Repair by pigtailing, using COPALUM\* connectors installed by a qualified electrician, is considered by the U.S. Consumer Product Safety Commission ("CPSC") to be the best method for a permanent repair short of rewiring with copper.[7] Their recommendation is based on extensive testing and successful long-term field experience. The application of COPALUM connectors is considered to be satisfactory without special preparation of the aluminum conductor.

The "COPALUM" connector is applied using a special set of dies in a power-driven tool. After application of the connector, a heat-shrink insulator is applied. Solid copper wire "pigtails" spliced to the aluminum wire this way may be connected to receptacles, switches, circuit breakers, lamps, appliances, and all other terminations in the normal manner. (Note: all aluminum branch circuit wire terminations in the home, including the ground wires, must be treated this way for a complete and permanent repair, as the overheating problem involves all types of aluminum-wired connections.) The COPALUM repair can only be obtained through an installer who has been trained and certified by the connector manufacturer. For information on availability in your location, call the manufacturer at 800-722-1111.

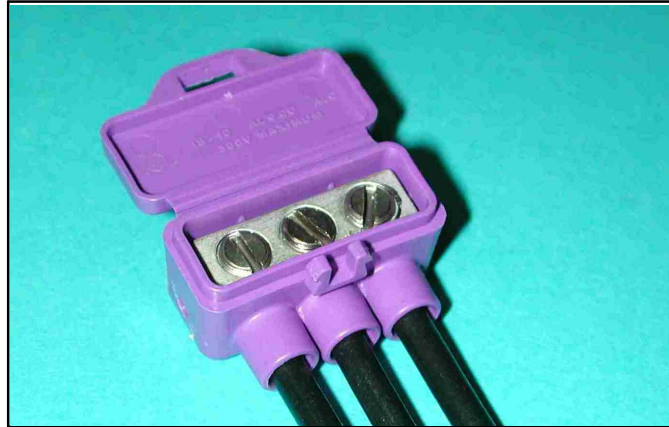
**FIGURE 4 - King Innovation "AlumiConn" Connector**

In mid-2006 a new connector became widely available for the aluminum wire pigtail application. This connector is shown in Figure 4. Test results for this connector have been published and are publicly available. [13] The CPSC now accepts use of the AlumiConn connector as an acceptable alternative repair method if the COPALUM repair cannot be implemented.

On the basis of the test results, the AlumiConn connector is predicted to have a high probability of failure-free long-term safe performance, *provided that the setscrews are carefully tightened according to the manufacturer's recommendation.*\* If not tightened to the manufacturer's recommendation, there is a possibility that the connections will degrade due to wire stresses and/or motion when the completed connection is manipulated into the outlet (or junction) box.
